Streambed Adjustment and Channel Widening in Eastern Nebraska

Water-Resources Investigations Report 03-4003

By David L. Rus, Benjamin J. Dietsch, U.S. Geological Survey, *and* Andrew Simon, National Sedimentation Laboratory

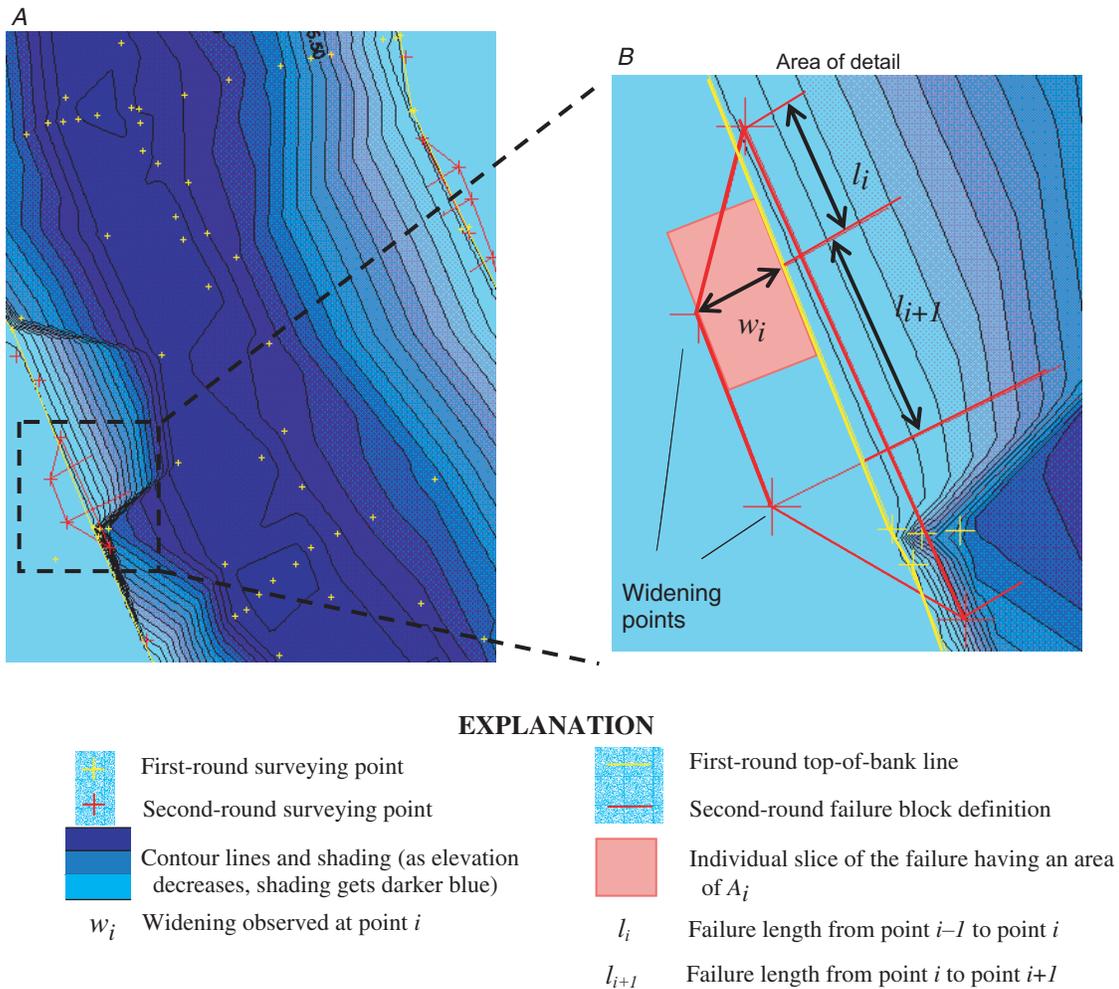
Figure 4. Characterization of top-of-bank (TOB) widening between first and second rounds of surveying by: (A) Identifying individual failures along the TOB, and (B) characterizing the geometry of each.

Once all of the failures were characterized at each site, widening rates were computed for the entire site. All of the failure areas were summed into a total failed area, A_r . The unit widening (in failed area per unit length of TOB) for the entire site then was

computed by dividing A_t by twice the length of the survey reach (because both banks were analyzed). The unit widening was divided by the time between first- and second-round surveys to compute the widening rate, expressed in meters of widening per year.

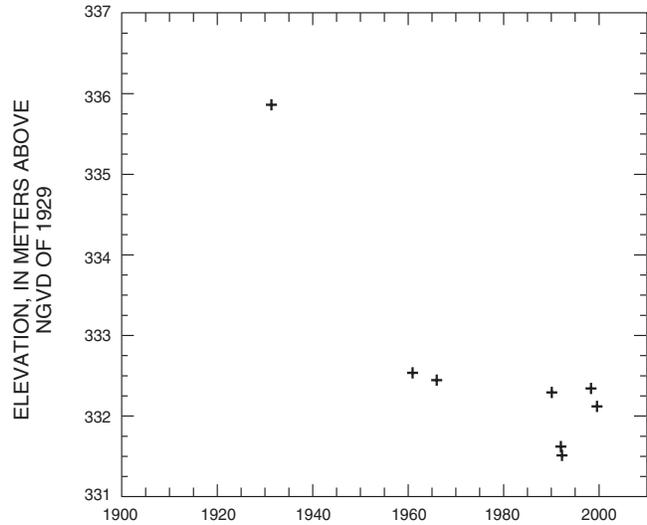
Figure 7. Streambed-elevation changes at Elk Creek at US20 (MRT-8).

Nine of the 23 Missouri River Tributary Basins sites showed degradation responses greater than 1 m (table 6). Site MRT-8 showed the largest amount of change, with 3.7 m of degradation between 1931 and

1999, and most of the change had occurred by 1960 (fig. 7). The streambed materials were coarser in the northeastern basins of Bow, Aowa, and Elk Creeks than in the rest of the basins studied (table 6).

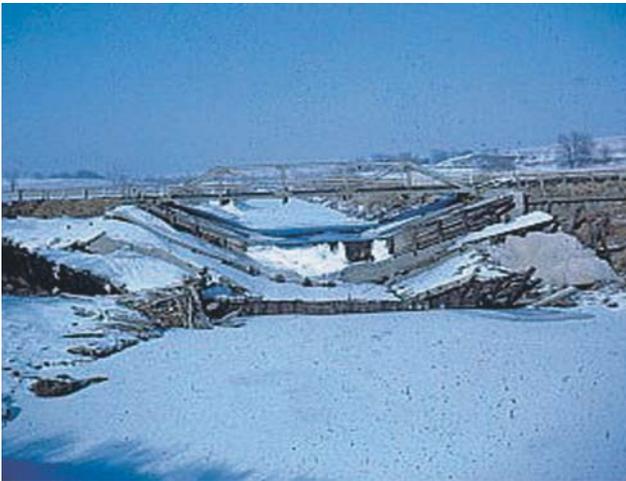
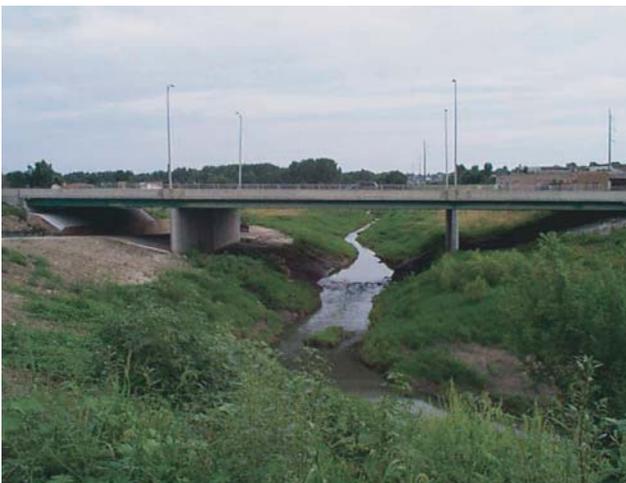
Figure 9. Looking upstream at W Papillion Cr at US275 (PC-3).

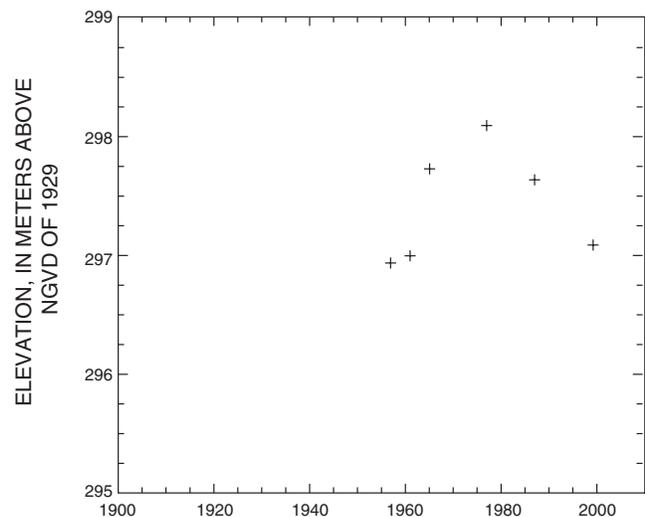
Figure 10. Streambed-elevation changes at W Papillion Cr at 66th Street (PC-H).

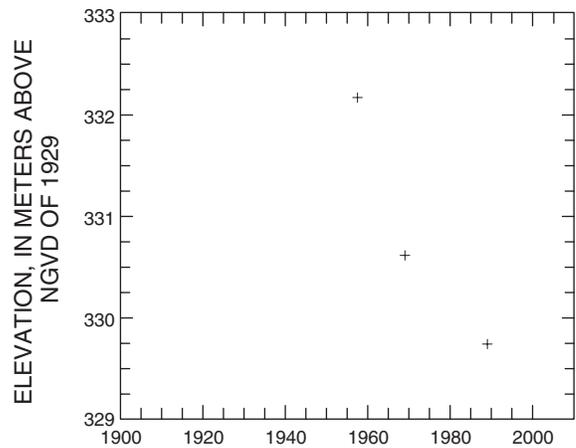
Figure 11. Streambed-elevation changes at Wehrspann Cr at N370 (PC-F).

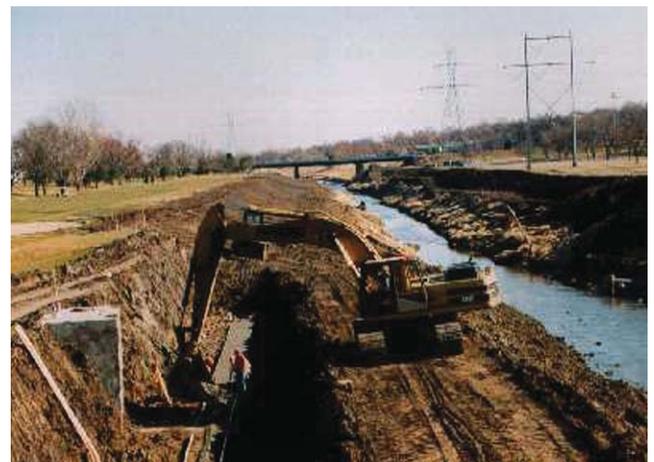
Figure 12. Channel and levee construction, Big Papillion Creek (photograph from the Papio-Missouri River Natural Resources District).

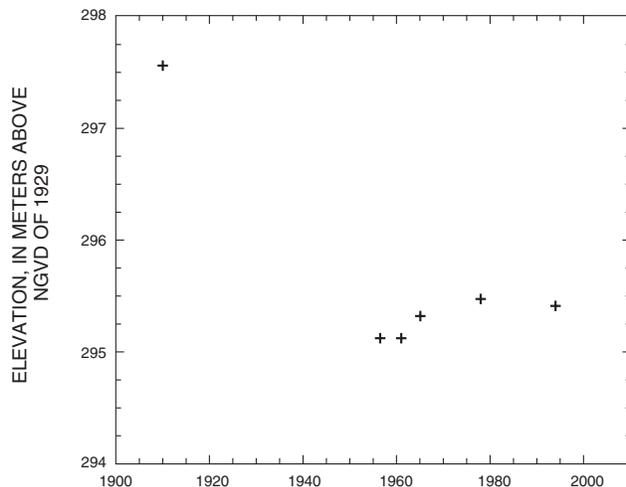
Figure 13. Streambed-elevation changes at Big Papillion Cr at Cornhusker Rd (PC-M).

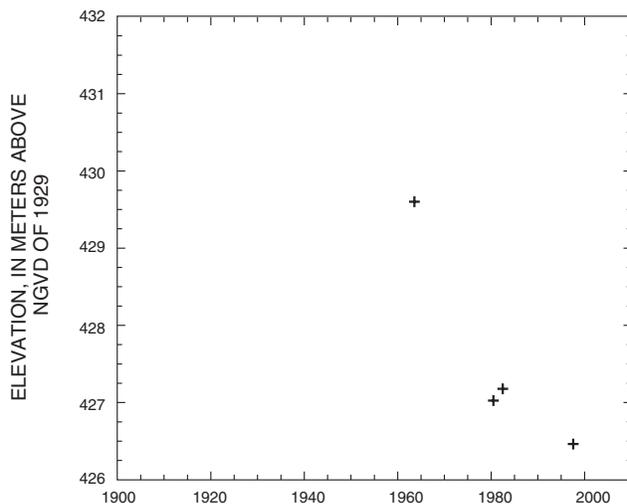
Figure 15. Streambed-elevation changes at Skull Creek at Butler County road (PRT-5).

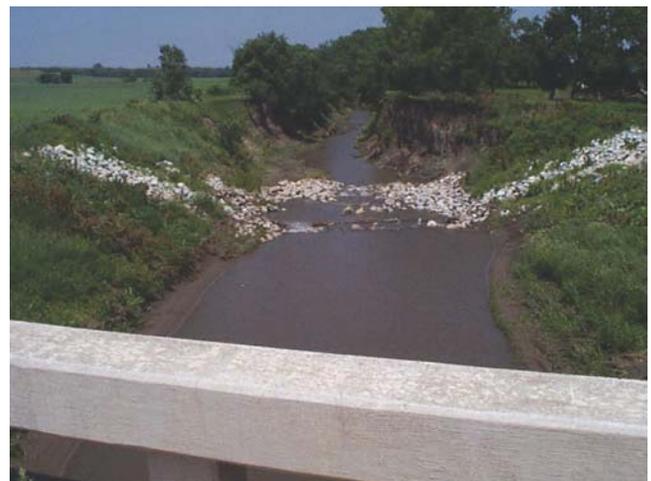
Figure 16. Looking downstream at grade-control structure on Skull Creek at PRT-5.

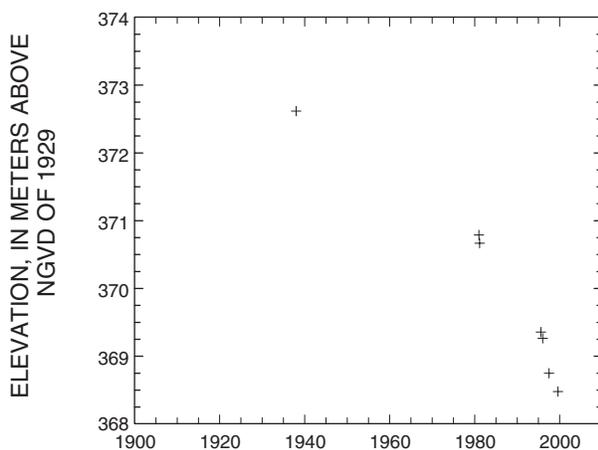
Figure 17. Streambed-elevation changes at Otoe Cr at US77 (PRT-7).

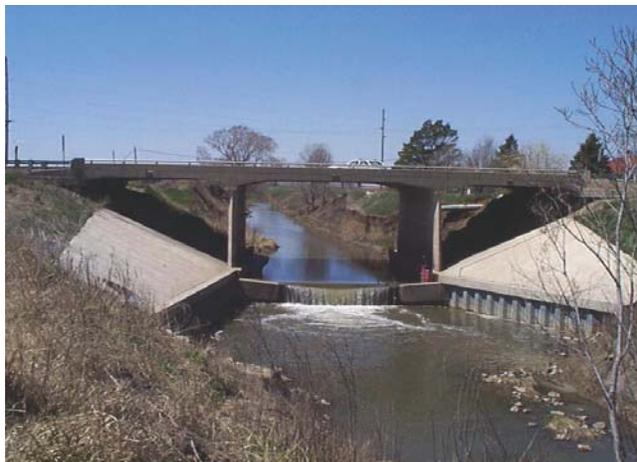
Figure 19. Drop structure at S Logan Cr at N15 (ER-12).

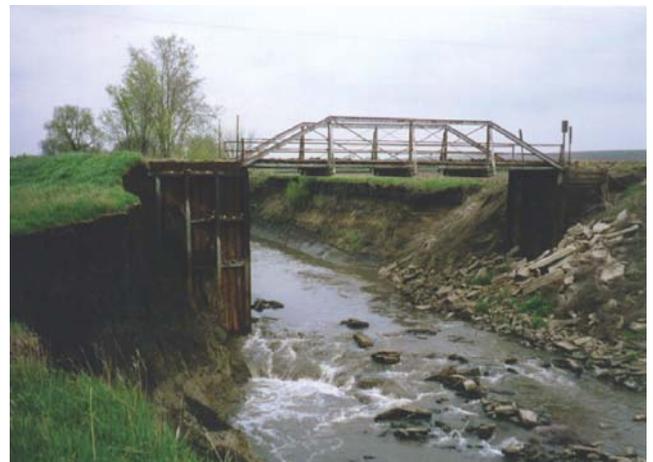
Figure 20. Knickpoint on East Fork Maple Creek located at SW1/4 sec. 26, T. 19 N., R. 4 E.

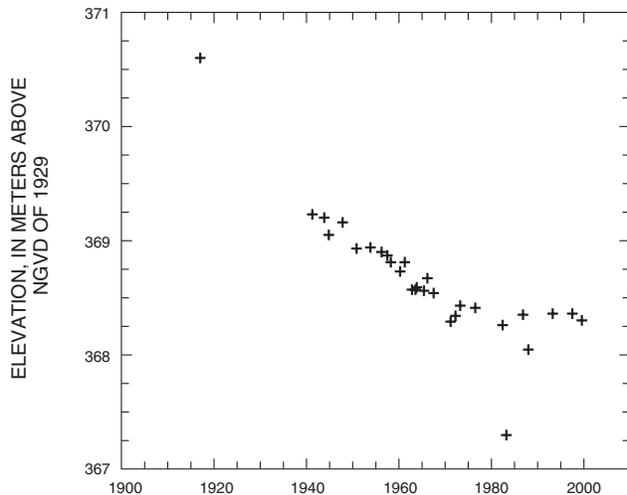
Figure 21. Streambed-elevation changes at Logan Cr at Dodge County Road 22 (ER-15).

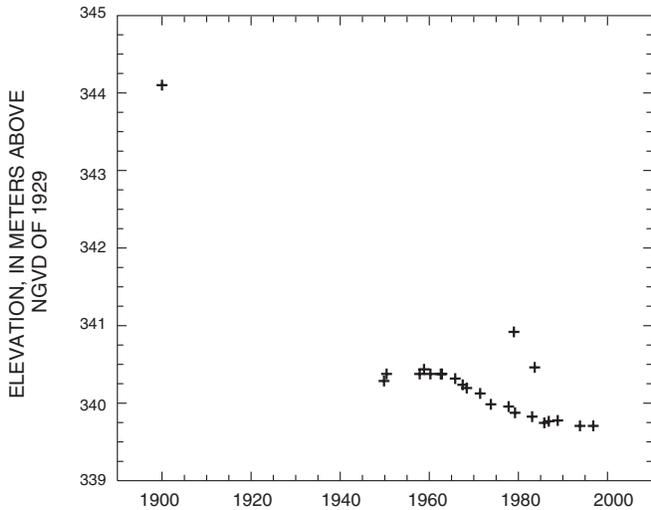
Figure 23. Streambed-elevation changes at Salt Cr at N 27th St, Lincoln (SC-13).

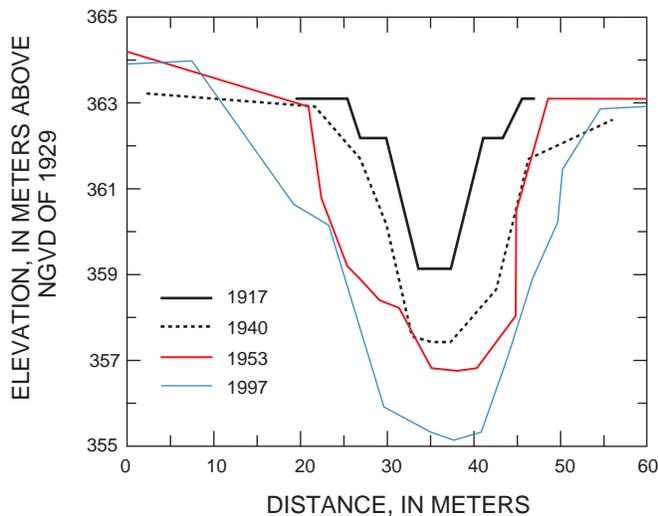
Figure 24. Stream channel response at Middle Cr at US6 (SC-7) following 1917 straightening.

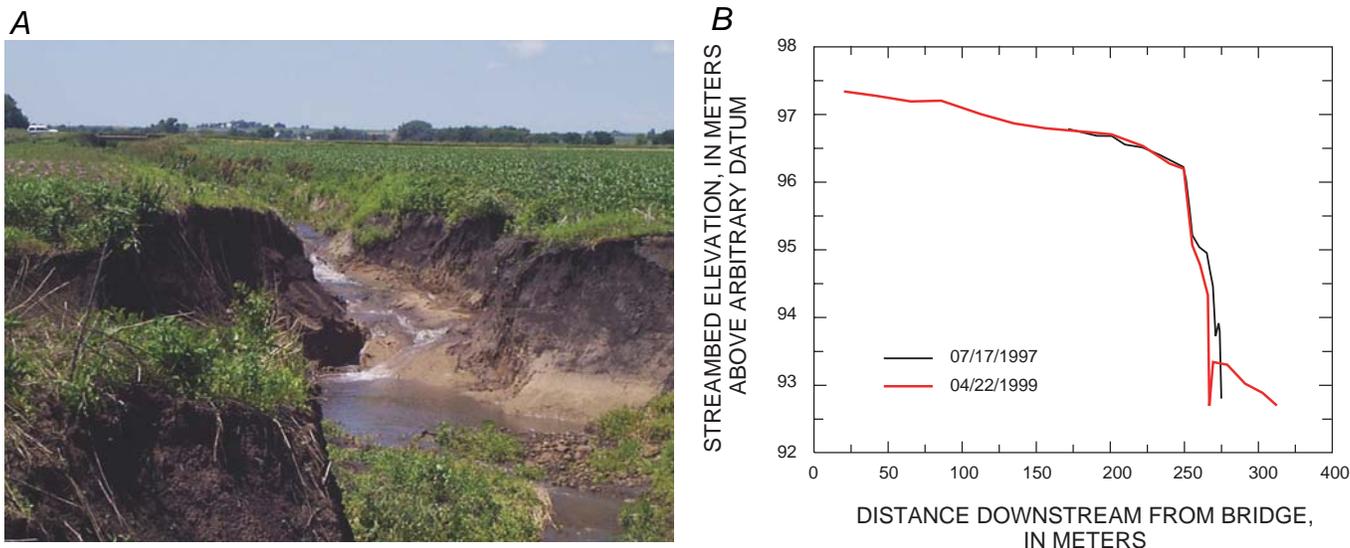
Figure 25. (A) Photograph of knickpoint and (B) streambed profile observed at Sand Cr Tributary at Saunders County Road 24 (SC-31).

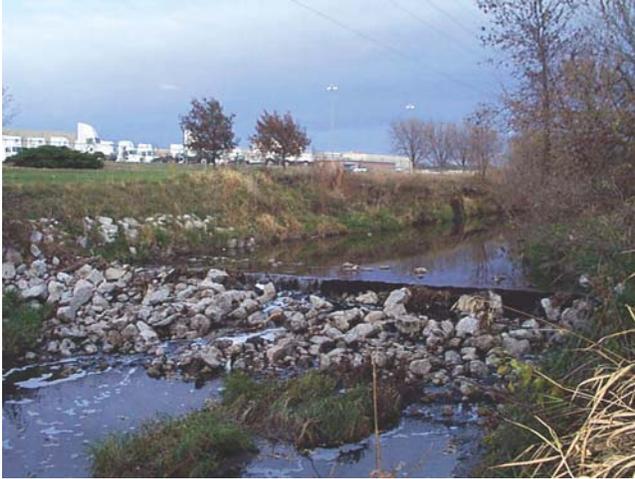
Figure 26. Grade-control structure on Beal Slough upstream from Link 55W (SC-H).

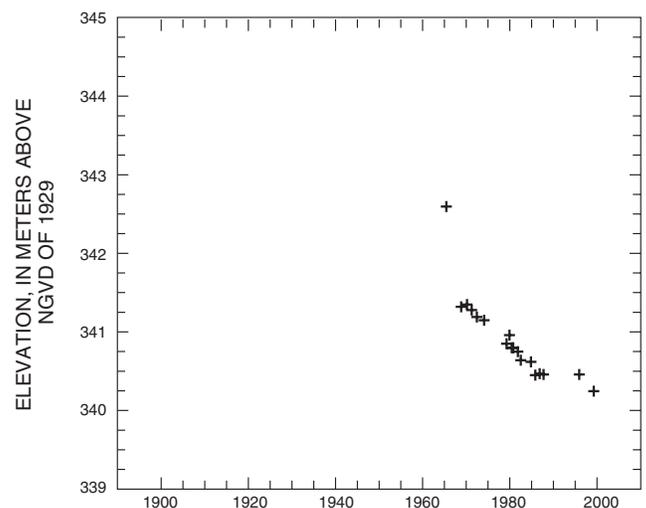
Figure 27. Streambed-elevation changes at Little Salt Cr at Arbor Road (SC-21).

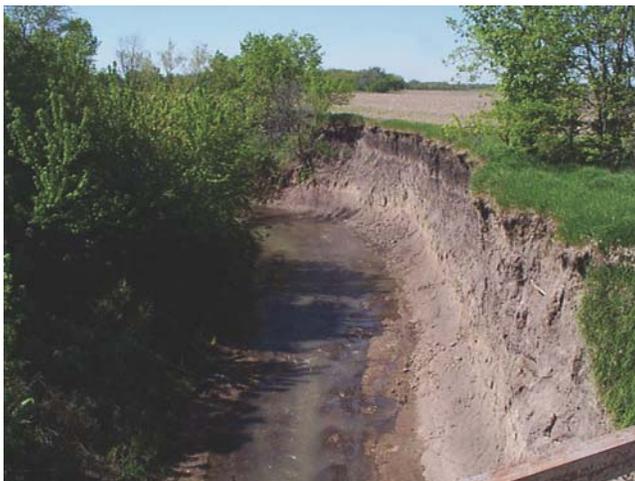
Figure 29. Channel incision observed in 1998 on Spring Creek about 3.5 kilometers upstream from LNR-11.

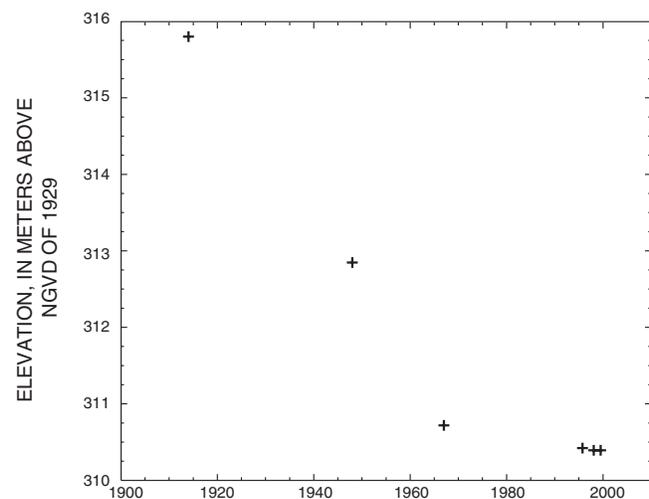
Figure 30. Streambed-elevation changes at S Fk Little Nemaha River at N50 (LNR-8).

Two of the three sites in the South Fork Little Nemaha River subbasin (LNR-8 and LNR-9) showed a response probably caused by the straightening in the subbasin between 1947 and 1953 (fig. 30; table 15). The third site, LNR-7, which is in the upper reaches of the subbasin, seems presently to be aggrading in response to the original channelization. This would indicate that a knickpoint created by the extension of the work may still be migrating upstream through the subbasin and is located between sites LNR-7 and LNR-8. Sites in the Muddy Creek subbasin had the most streambed degradation of any of the sites in the basin, with 6.0 m of change at LNR-B and 5.4 m of change at LNR-6 (table 15).

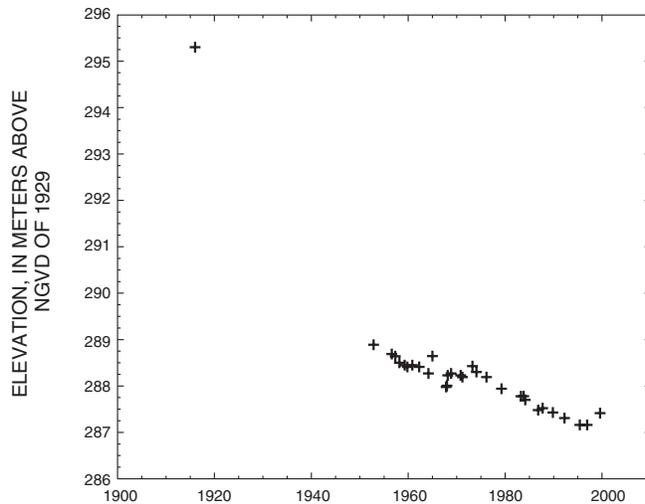
Figure 32. Streambed-elevation changes at N Fk Big Nemaha R at N105 (BNR-9).

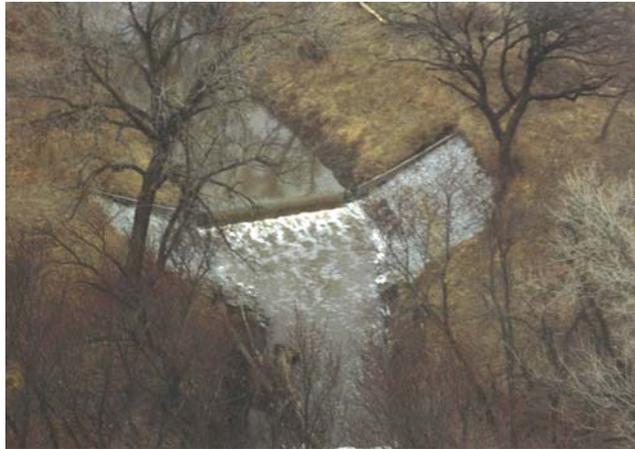
Figure 34. Grade-control structure on Big Indian Creek between Gage County Road (BBR-11) and US77 (BBR-12).

Of the six sites on tributaries that have been straightened, only BBR-12 showed any streambed degradation greater than 1 meter (table 18). This may be a result of grade-control structures, but also might be the result of insufficient data at the other sites. Bedrock currently is exposed at site BBR-12, which has effectively halted any further degradation.
